**Flood Control Project Maintenance
Levee Inspections**

Maintenance Issue Types Only, Levee Inspection Report By Mile - Spring 2019

Reclamation District No. 0551 Pearson

Waterway	Bank	Unit Miles	Inspection Start/End	Inspector
Unit No. 01 Sacramento River	Left	6.78	03/15/2019 03/15/2019	David Julian

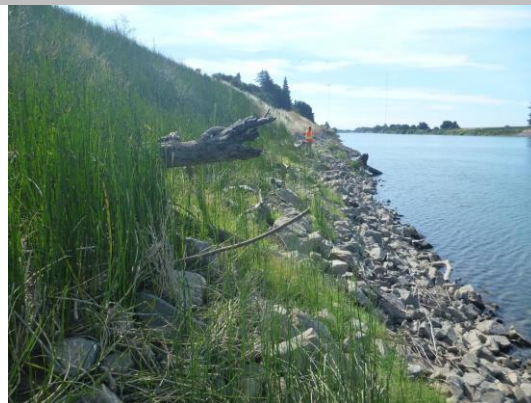
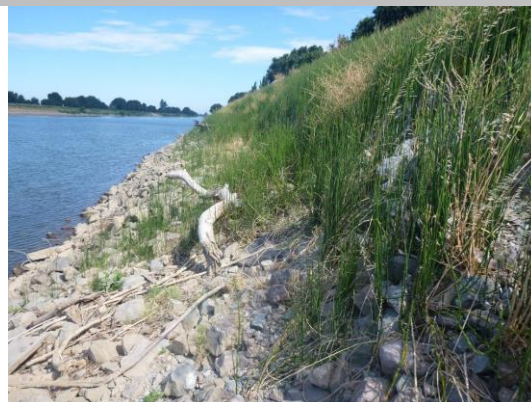
LM Start	5.38	Rating **	A/W	Issue No.	35 (cont)
LM End	5.42	Issue Type +	Ma	Location *	
Category	Supplemental		GPS Latitude/Longitude		
			Start	End	
Item	2017 Storm Damage		38.272867 °	38.272411 °	
			-121.536597 °	-121.535983 °	
DWR ID	DWR_RD0551_01_f_2017_35

Comment Code					
Inspector Comment					
<p>Levee Evaluation Comments</p> <p>Description: District Station 283+08 to 285+49, Sec. 22, T. 5 N. R. 4 E., M.D.M. Approximately 241 linear-feet of erosion and sloughing exists along the waterside slope of the Sacramento River. The erosion commences approximately 3/4 of the way down the slope and extends to the rip rap. Some existing rip rap has been pulled off in this section.</p> <p>Site ID No: 343</p> <p>Site Designation: LMA-170</p> <p>Repair Type: Erosion</p> <p>Rating: Area of Concern</p> <p>Field Date: 7/14/2017</p> <p>Notes: Crown is a paved road. Scarps above rip rap 2-4 ft deep, but not continuous through whole site. Area of concern because erosion is not very deep into prism and is not continuous throughout site.</p>

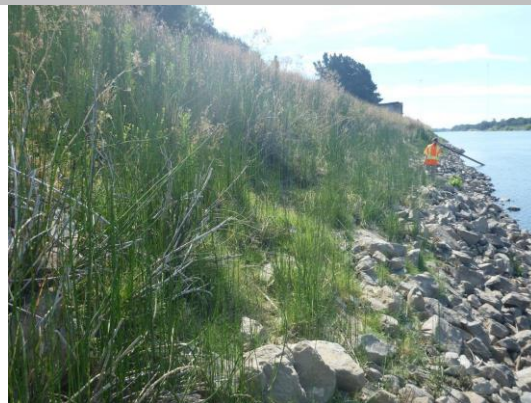
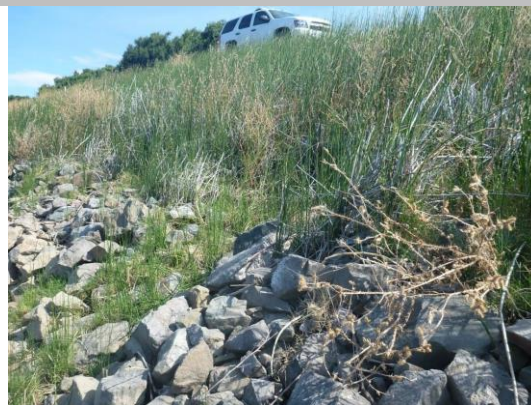
LM Start	5.52	Rating **	A/W	Issue No.	36
LM End	5.54	Issue Type +	Ma	Location *	
Category	Supplemental			GPS Latitude/Longitude	
				Start	End
Item	2017 Storm Damage			38.271406 °	38.271208 °
				-121.534644 °	-121.534381 °
DWR ID	DWR_RD0551_01_f_2017_36

Comment Code					
Inspector Comment					
Levee Evaluation Comments					
Description:District Station 290+80 to 291+85, Sec. 22, T. 5 N. R. 4 E., M.D.M. Approximately 105 linear-feet of erosion and sloughing exists along the waterside slope of the Sacramento River. The erosion commences approximately 3/4 of the way down the slope and extends into the rip rap. Some existing rip rap has been pulled off in this section.					
Site ID No:344					
Site Designation:LMA-171					
Repair Type: Erosion					
Rating:Area of Concern					
Field Date:7/14/2017					
Notes: Crown is a paved road. Erosion scarps 1-4 ft deep just above rip rap. Area of concern because erosion is not very deep into prism.

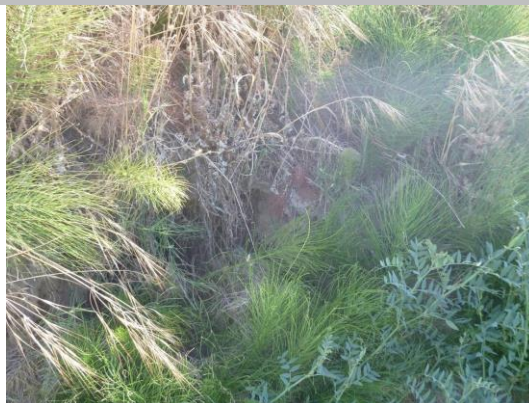
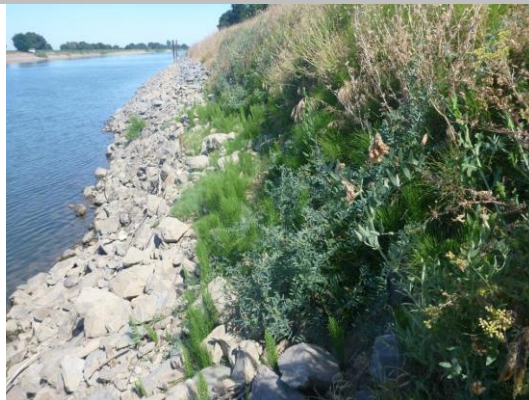
LM Start	5.77	Rating **	A/W	Issue No.	37 (cont)	
LM End	5.79	Issue Type +	Ma	Location *		
Category	Supplemental			GPS Latitude/Longitude		
				Start	End	
Item	2017 Storm Damage			38.269025 °	38.268814 °	
				-121.531361 °	-121.531058 °	
DWR ID	DWR_RD0551_01_f_2017_37

Comment Code						
Inspector Comment						
Levee Evaluation Comments						
Description:District Station 303+60 to 304+75, Sec. 22, T. 5 N. R. 4 E., M.D.M. Approximately 115 linear-feet of erosion and sloughing exists along the waterside slope of the Sacramento River. The erosion occurs just above the rip rap line. Some existing rip rap has been pulled off in this section.						
Site ID No:345						
Site Designation:LMA-172						
Repair Type: Erosion						
Rating:Area of Concern						
Field Date:7/14/2017						
Notes: Crown is a paved road. 4 ft deep scarp above the rip rap. Area of concern because erosion is not very deep into prism and there was lots of vegetation growing in the damaged area indicating it may be an older issue.

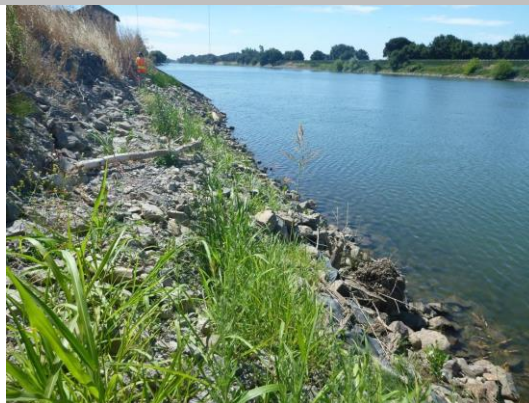
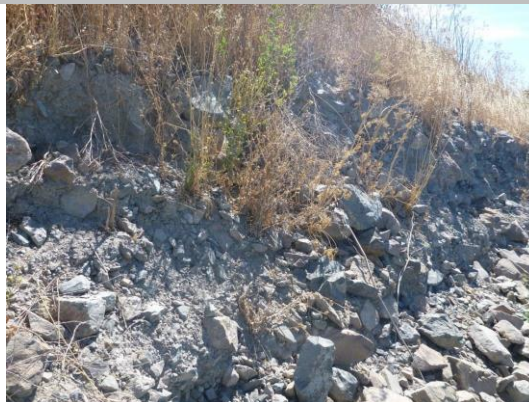
LM Start	5.85	Rating **	M	Issue No.	38
LM End	5.86	Issue Type +	Ma	Location *	
Category	Supplemental			GPS Latitude/Longitude	
				Start	End
Item	2017 Storm Damage			38.268244 °	38.268139 °
				-121.530233 °	-121.530075 °
DWR ID	DWR_RD0551_01_f_2017_38

Comment Code					
Inspector Comment					
Levee Evaluation Comments					
Description:District Station 307+90 to 305+49, Sec. 22, T. 5 N. R. 4 E., M.D.M. Approximately 59 linear-feet of erosion exists along the waterside slope of the Sacramento River. The erosion occurs approximately halfway down the slope within the rip rapped area. Existing rip rap has been pulled off in this section.					
Site ID No:346					
Site Designation:LMA-173					
Repair Type: Erosion					
Rating:Area of Concern					
Field Date:7/14/2017					
Notes: Crown is a paved road. Erosion scarps 4-6 ft high, but soil is more stable than other nearby sites with large gravel in silt or clay so we rated this as an area of concern.

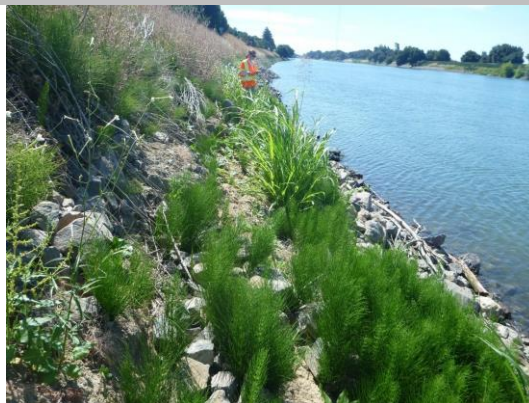
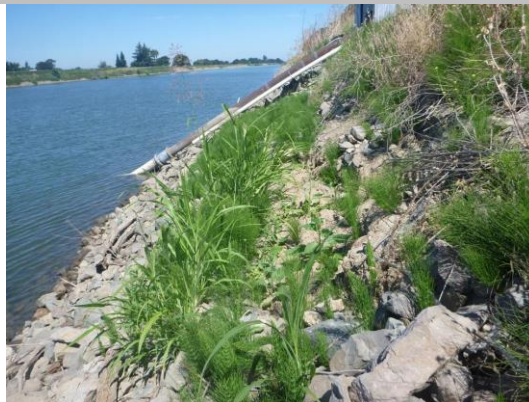
LM Start	5.88	Rating **	M	Issue No.	39 (cont)	
LM End	5.90	Issue Type +	Ma	Location *		
Category	Supplemental			GPS Latitude/Longitude		
				Start		End
Item	2017 Storm Damage			38.267989 °		38.267775 °
				-121.529853 °		-121.529533 °
DWR ID	DWR_RD0551_01_f_2017_39

Comment Code						
Inspector Comment						
Levee Evaluation Comments						
Description:District Station 309+33 to 310+53, Sec. 22, T. 5 N. R. 4 E., M.D.M. Approximately 120 linear-feet of erosion and sloughing exists along the waterside slope of the Sacramento River. The erosion commences approximately halfway down the slope, extending into the rip rap. Some existing rip rap has been pulled off in this section.						
Site ID No:347						
Site Designation:LMA-174						
Repair Type: Erosion						
Rating:Area of Concern						
Field Date:7/14/2017						
Notes: Crown is a paved road. Pump house in the middle of this site. 18 inch scarps in and just above top of rip rap. Area of concern because erosion is not very deep into prism.

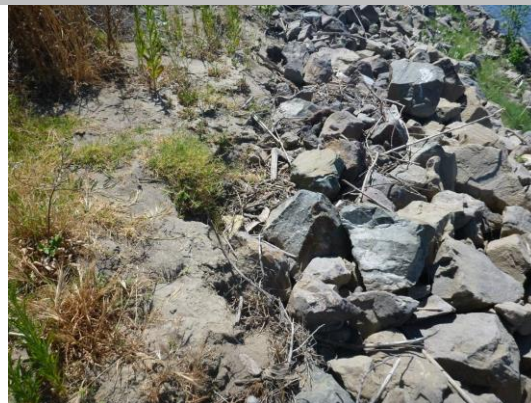
Photo 3 of 3 : SP_2019_RD0551_175_40_20190311_00059.jpg

LM Start	5.95	Rating **	M	Issue No.	40 (cont)
LM End	5.97	Issue Type +	Ma	Location *	
Category	Supplemental		GPS Latitude/Longitude		
			Start	End	
Item	2017 Storm Damage		38.267286 °	38.267094 °	
			-121.528886 °	-121.528642 °	
DWR ID	DWR_RD0551_01_f_2017_40

Comment Code					
Inspector Comment					
<p>Levee Evaluation Comments</p> <p>Description: District Station 313+15 to 314+15, Sec. 22, T. 5 N. R. 4 E., M.D.M. Approximately 100 linear-feet of erosion and sloughing exists along the waterside slope of the Sacramento River. The erosion commences approximately halfway down the slope and extends into the rip rap. Some existing rip rap has been pulled off in this section.</p> <p>Site ID No: 349</p> <p>Site Designation: LMA-176</p> <p>Repair Type: Erosion</p> <p>Rating: Area of Concern</p> <p>Field Date: 7/14/2017</p> <p>Notes: 18 in to 3 ft vertical scarps just above rip rap. Crown is a paved road. Area of concern because erosion is not very deep into prism.</p>

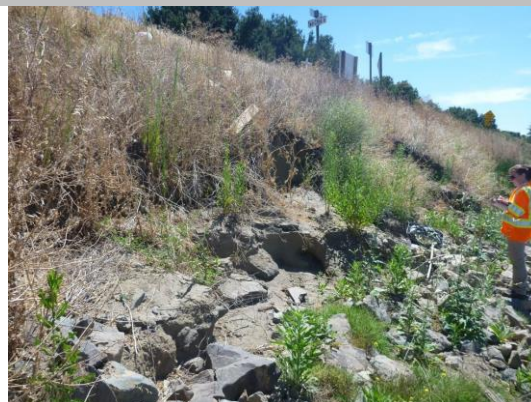
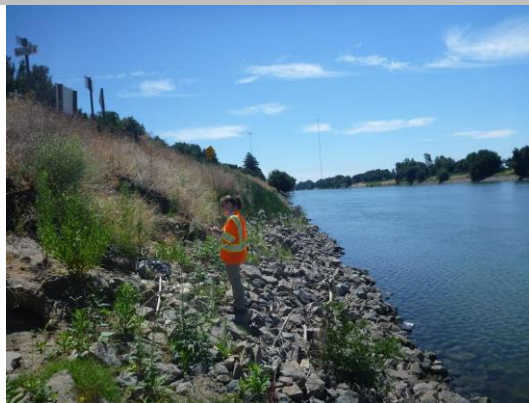
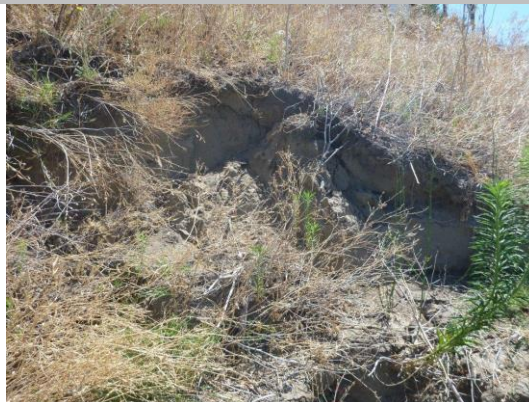
LM Start	6.01	Rating **	M	Issue No.	41
LM End	6.08	Issue Type +	Ma	Location *	
Category	Supplemental		GPS Latitude/Longitude		
			Start	End	
Item	2017 Storm Damage		38.266686 °	38.265917 °	
			-121.528128 °	-121.527194 °	
DWR ID	DWR_RD0551_01_f_2017_41

Comment Code					
Inspector Comment					
<p>Levee Evaluation Comments</p> <p>Description: District Station 316+24 to 320+12, Sec. 22, T. 5 N. R. 4 E., M.D.M. Approximately 388 linear-feet of erosion exists along the waterside slope of the Sacramento River. The erosion commences approximately halfway down the slope and extends into the rip rap. Some existing rip rap has been pulled off in this section.</p> <p>Site ID No: 350</p> <p>Site Designation: LMA-177</p> <p>Repair Type: Erosion</p> <p>Rating: Area of Concern</p> <p>Field Date: 7/14/2017</p> <p>Notes: Crown is paved road. Erosion scarps between 1-6 ft deep. Area of concern because the deeper erosion only extended for a short distance.</p>

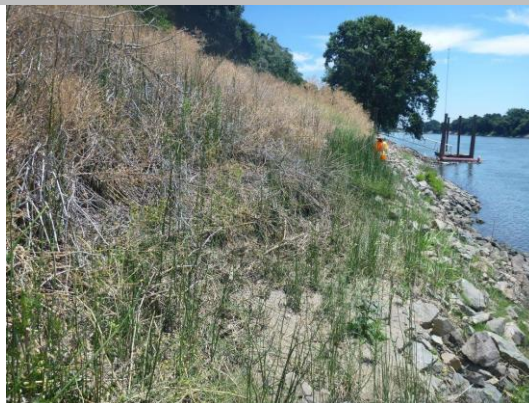
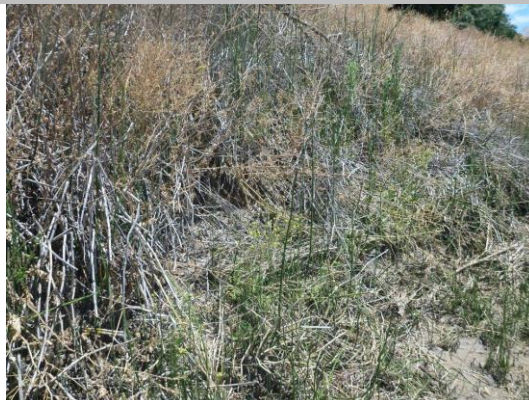
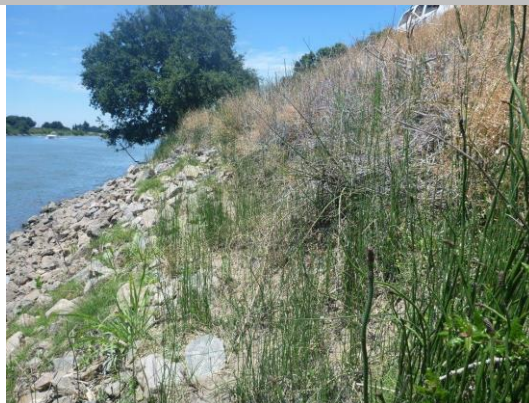
LM Start	6.22	Rating **	A/W	Issue No.	42
LM End	6.24	Issue Type +	Ma	Location *	
Category	Supplemental			GPS Latitude/Longitude	
				Start	End
Item	2017 Storm Damage			38.264436 °	38.264233 °
				-121.525472 °	-121.525219 °
DWR ID	DWR_RD0551_01_f_2017_42

Comment Code					
Inspector Comment					
Levee Evaluation Comments					
Description:District Station 327+45 to 328+45, Sec. 22, T. 5 N. R. 4 E., M.D.M. Approximately 100 linear-feet of erosion and sloughing exists along the waterside slope of the Sacramento River. The erosion commences approximately halfway down the slope and extends into the rip rap. Existing rip rap has been pulled off in this section.					
Site ID No:351					
Site Designation:LMA-178					
Repair Type: Erosion					
Rating:Serious					
Field Date:7/14/2017					
Notes: Crown is a paved road. Scarps above rip rap are about 7 ft deep. Rated this serious because erosion scarps are pretty deep, sandy material, steep slope, the rip rap is in poor condition and high traffic on the levee road.

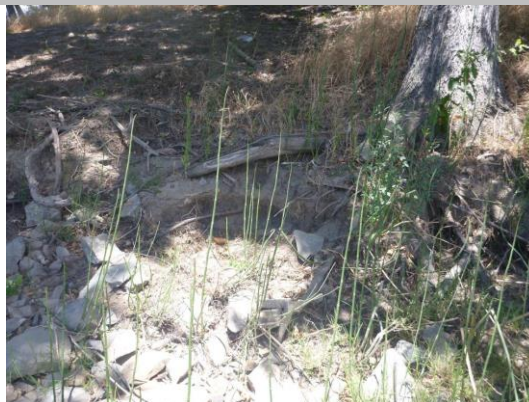
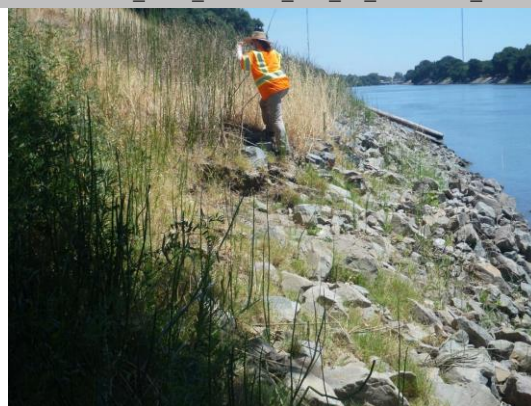
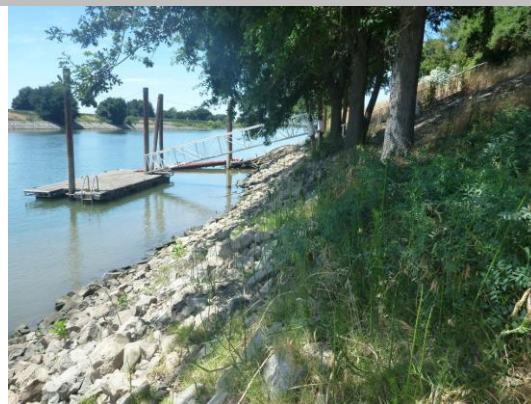
LM Start	6.27	Rating **	A/W	Issue No.	43
LM End	6.29	Issue Type +	Ma	Location *	
Category	Supplemental		GPS Latitude/Longitude		
			Start	End	
Item	2017 Storm Damage		38.263906 °	38.263756 °	
			-121.524778 °	-121.524575 °	
DWR ID	DWR_RD0551_01_f_2017_43

Comment Code					
Inspector Comment					
<p>Levee Evaluation Comments</p> <p>Description: District Station 330+19 to 330+99, Sec. 22, T. 5 N. R. 4 E., M.D.M. Approximately 80 linear-feet of erosion/sloughing and minor slippage exists along the waterside slope of the Sacramento River. The erosion/sloughing commences approximately halfway down the slope and extends into the rip rap. Existing rip rap has been pulled off in this section.</p> <p>Site ID No: 352</p> <p>Site Designation: LMA-179</p> <p>Repair Type: Erosion</p> <p>Rating: Area of Concern</p> <p>Field Date: 7/14/2017</p> <p>Notes: Crown is a paved road. Erosion scarps are only 1 ft deep. Area of concern because erosion is not very deep into prism.</p>
